B-3351 - B-3358

INVENTORY FORM FOR STATE HISTORIC SITES SURVEY

1028-1038 Patapsco St.

APPLICATION — PART 1

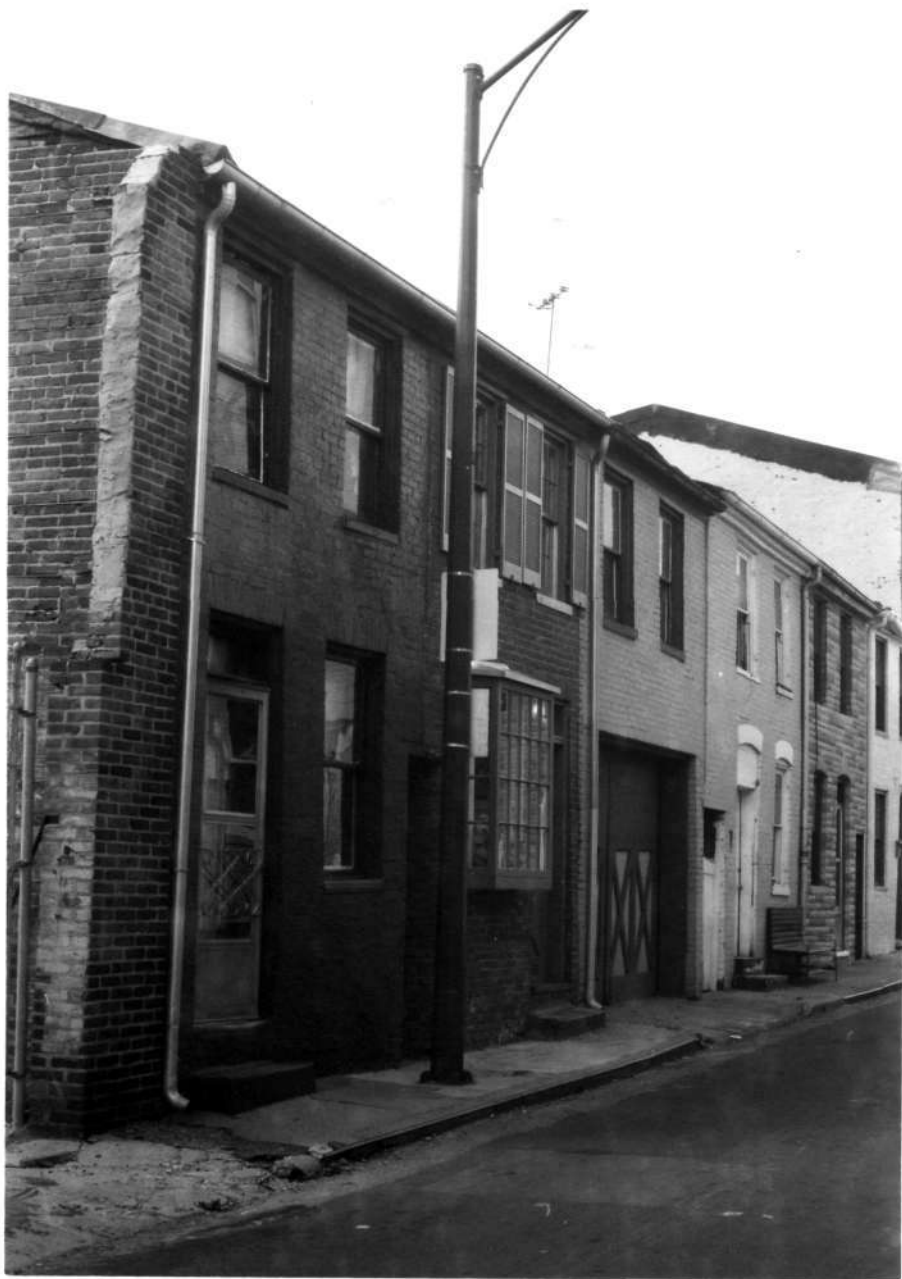
1028-1038 Patapsco

East elevation

This group of six two story brick houses with gable roofs was built in the 1850's. The houses are extremely small in scale. Several have recently been renovated with the first floor areas serving as store-fronts. Others are currently in the process of renovation.

The houses are two stories in height, range in width from about 11' wide to 14' wide, and occupy lots ranging in depth from 51' to 54 1/2' deep. Each house is two small rooms deep. Each house seems originally to have had a one story high, two bay deep rear addition. These survive at 1028 and 1030 Patapsco; 1032 has no rear additions and at this point in time, no rear wall at all; 1034 has a new one story high, two bay deep addition; 1036 has a new one story high, one bay deep addition; and 1038 has a new two story high, two bay deep addition. The houses are constructed in common bond, but 1030 Patapsco has a new facade of running bond and 1032 Patapsco is covered with formstone. The low-pitched gable roofs have two-tier brick cornices. 1028 Patapsco has single chimneys located on both the front and rear roof gables along the south side of the house; 1030 and 1032 Patapsco share a paired rectangular chimney located at the peak of the gable roof; 1034 Patapsco has a single chimney located along the rear roof gable on the south side of the house; and 1036 and 1038 Patapsco share a double hooded chimney located along the partition wall between the two houses on the rear roof gable.

1028 and 1034 Patapsco currently have no lintels on the window openings; 1030 Patapsco, which has a new brick facade has vertical stretcher lintels on the first floor windows and no lintels on the second floor windows; 1032 is covered with formstone so the original treatment of the lintels is hidden; 1036 and 1038 have splayed brick lintels on the first floor windows and flat wood lintels on the second floor windows. All of the sills on all of the houses are wood. The window openings of 1028, 1030, 1034, and 1036 are filled with new 6/6 double hung sash. 1032 has 1/1 double hung sash and 1038 currently has no sash, but when renovation is complete will also have new 6/6 sash. All of the houses originally had single light transoms. 1028 Patapsco has a glass and panel door, 1030 has a modern flush door; 1032 has a Mission-style door; and 1038 currently has no door. The first floor areas of 1034 and 1036 have been converted into store-fronts. At 1034 there are three new multi-light French-style doors, set beneath a plain wood siding cornice. At 1036 a panel door with multi-light section above, is set beneath a three-light transom in the northernmost bay. To the left there is a new bay window with multi-light sash. There are no basements, and all of the houses except for 1036-1038 are reached directly from the sidewalk. The entrances of 1036 and 1038 Patapsco are reached by one stone step each. A flat-roofed alleyway runs between 1036 and 1038 Patapsco and back under the northernmost bay of 1030 Patapsco.
